Collision Repair Work Based Learning

Taylor Johns

1997 Toyota 4Runner
SR5

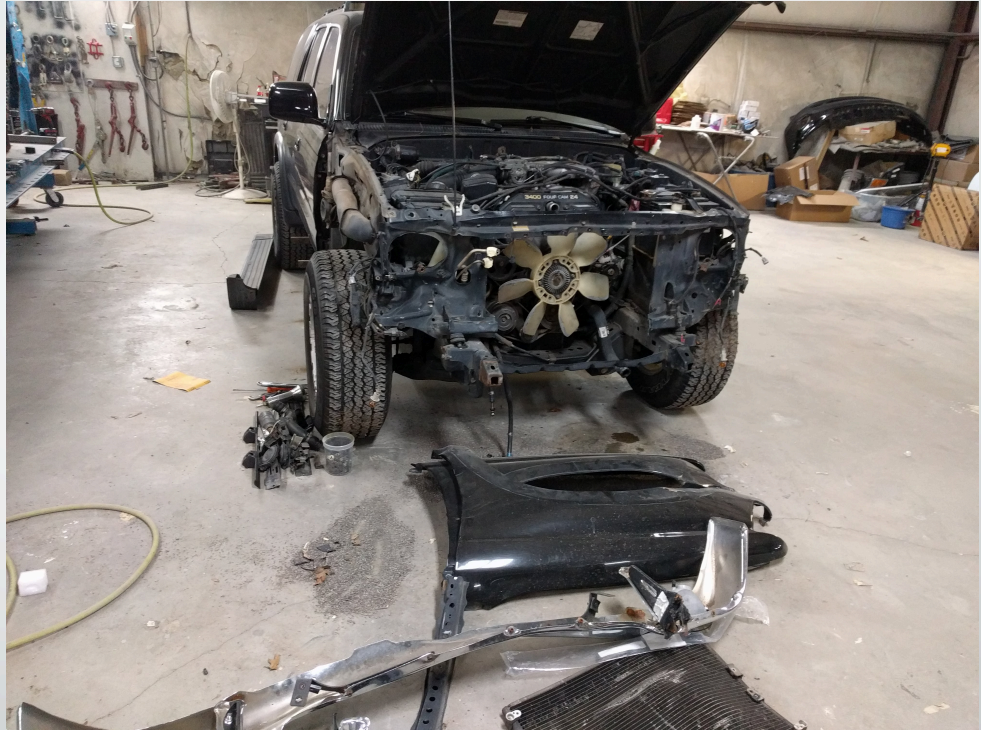
Radiator core support is to
be removed and replaced

Upper frame rails pulled in,
require frame pulling to
widen front

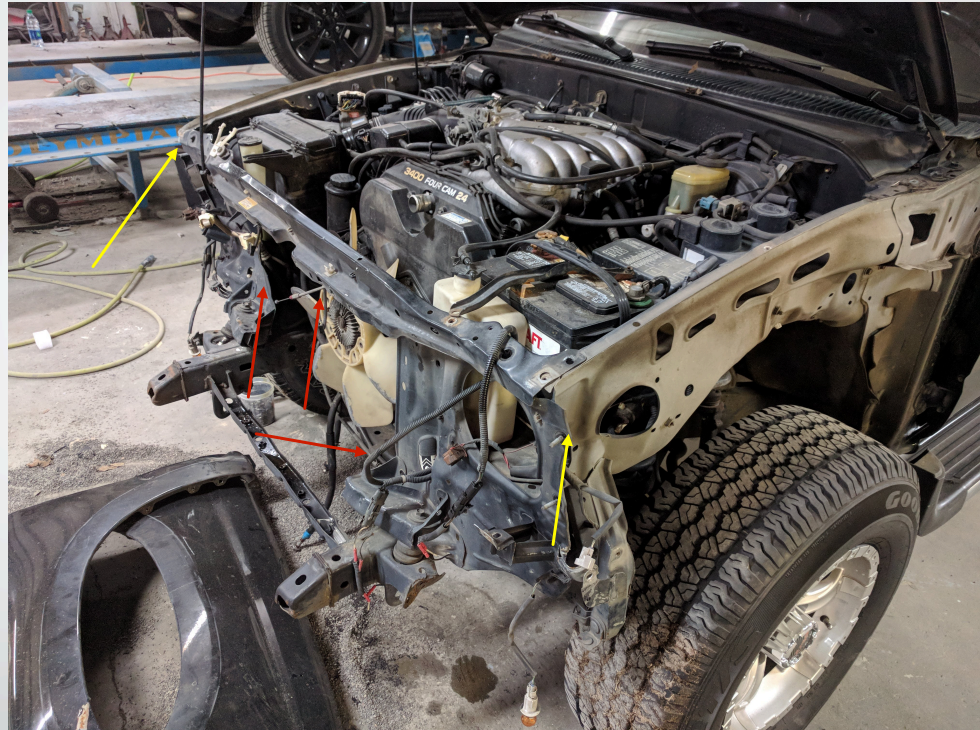
Damaged radiator core
support removed and new
being test fitted after frame
pulling

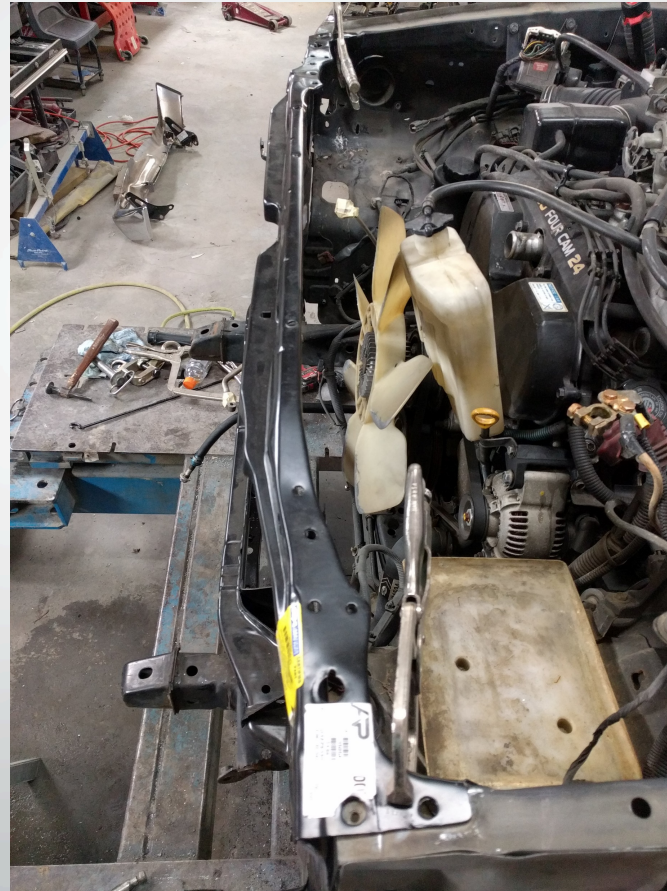
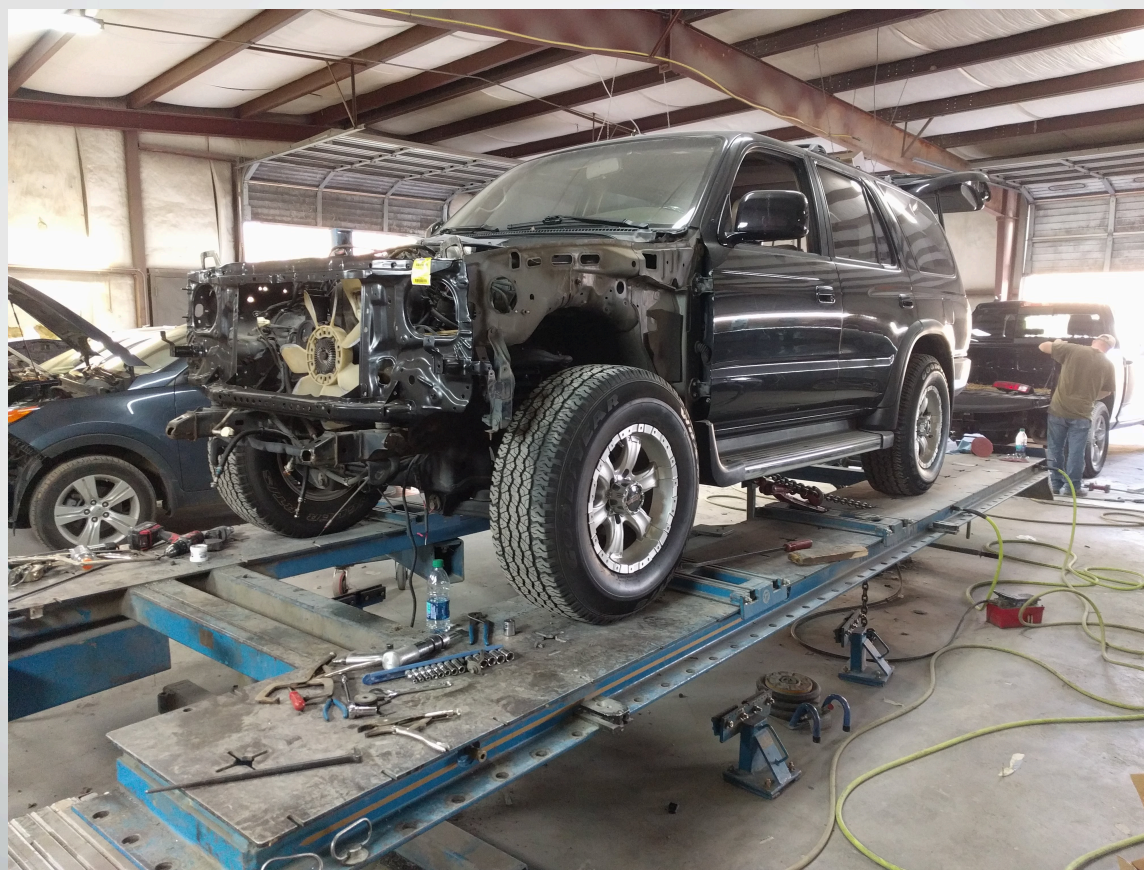
New radiator core support
welded in place, scuffed, and
painted in black trim paint to
prevent rust

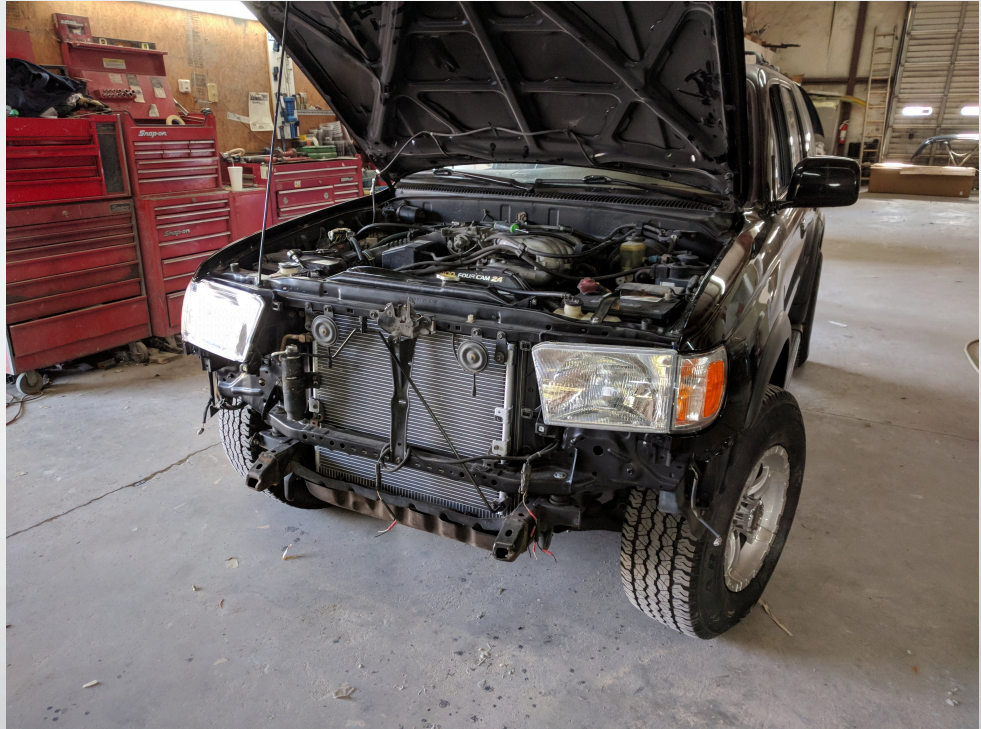
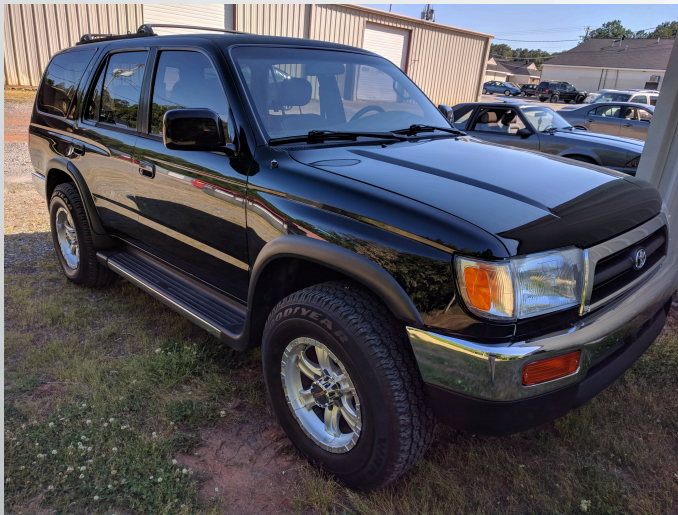
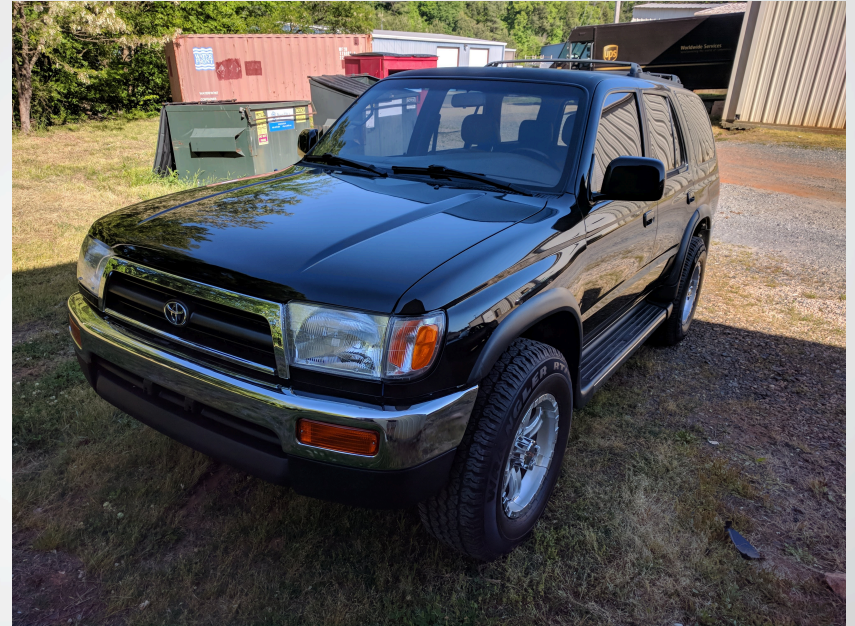
Final paint and assembly
